11th May 2017

Our Ref: DR17/418A-3

Site: Proposed Development Site
Lancaster Close
Fakenham
Norfolk
NR21 8DJ

CCTV SURVEY REPORT

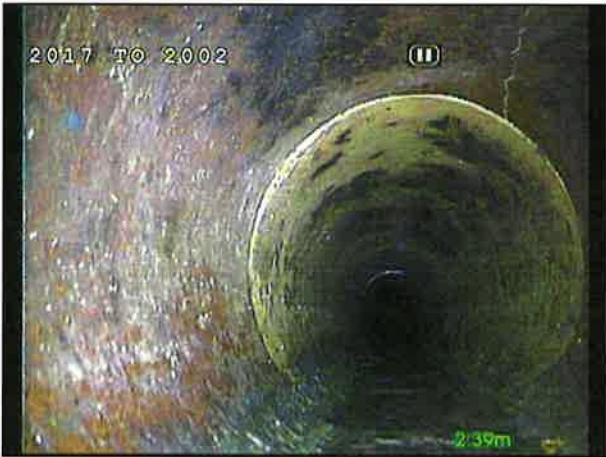
The pipework is serviceable but would benefit from high-pressure cleaning to remove general debris/sewage scale. Minor defects were noted. This cleaning/remedial work would fall under the responsibility of Anglian Water.

Photo: 2_2a, 00:00:00
2.39m, Crack Longitudinal at 01 o'clock

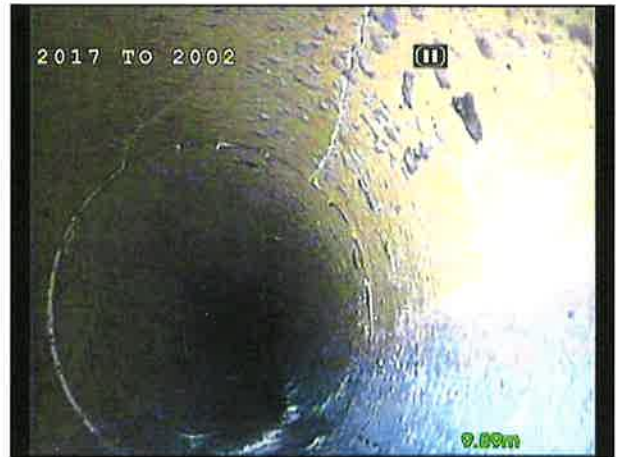
Photo: 4_4a, 00:00:00
9.89m, Crack Longitudinal at 01 o'clock

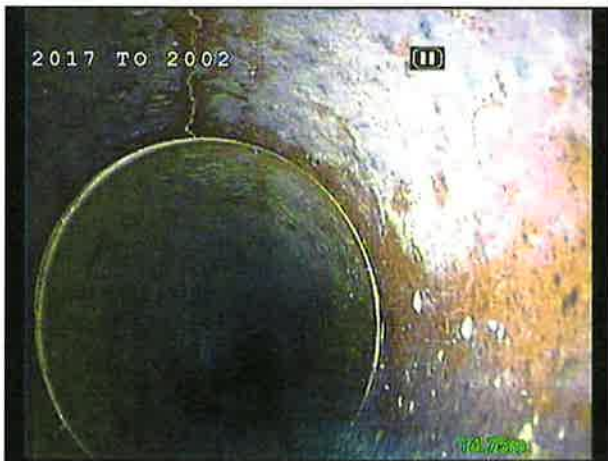
Photo: 5_5a, 00:00:00
14.75m, Crack Longitudinal at 12 o'clock

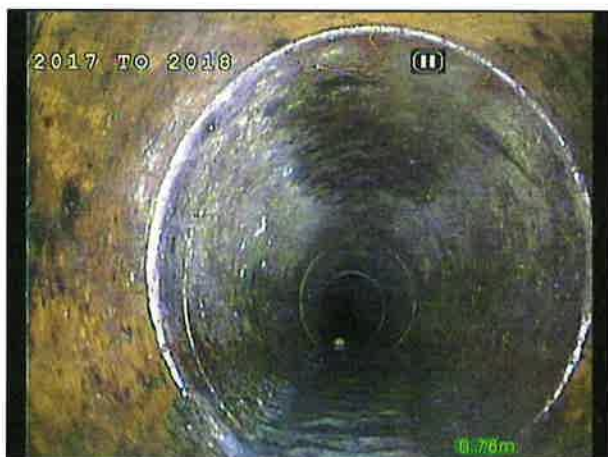
Photo: 8_2a, 00:00:00
0.78m, Crack Circumferential from 06 to 09 o'clock

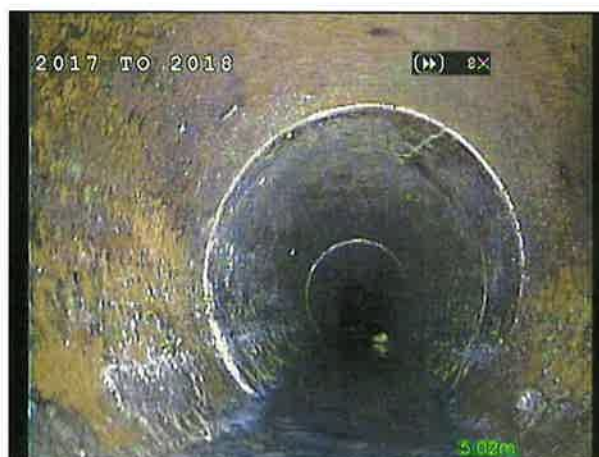
Photo: 9_3a, 00:00:00
5.02m, Crack Circumferential from 01 to 04 o'clock

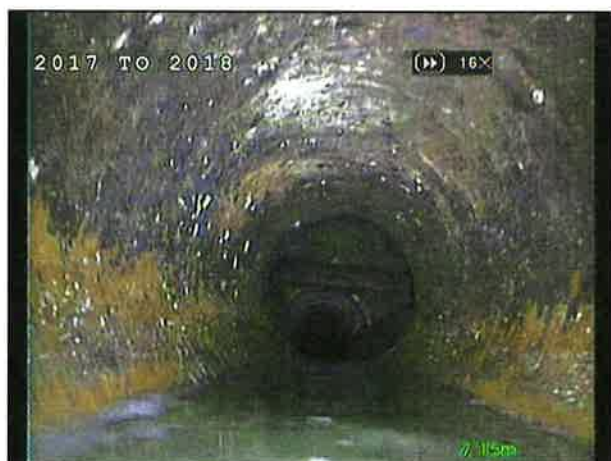
Photo: 10_4a, 00:00:00
6.97m, Crack Circumferential from 03 to 09 o'clock

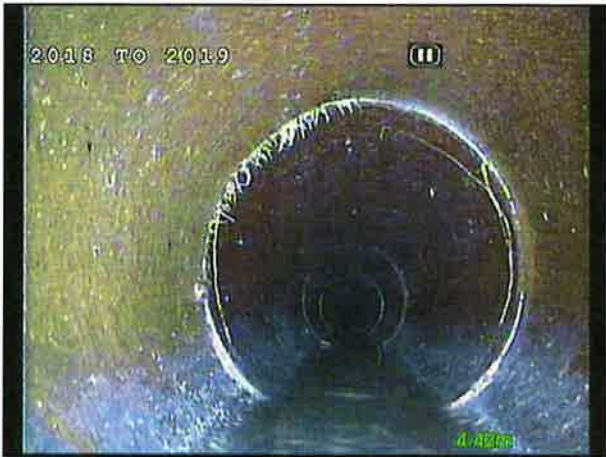
Photo: 17_6a, 00:00:00
 4.42m, Crack Circumferential from 08 to 04 o'clock

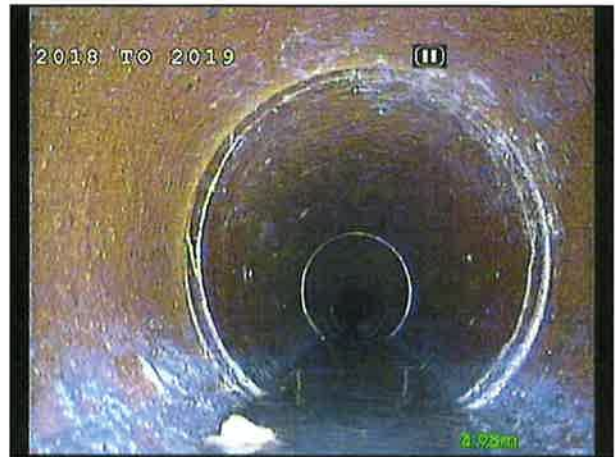
Photo: 18_7a, 00:00:00
 4.98m, Crack Circumferential from 12 to 12 o'clock

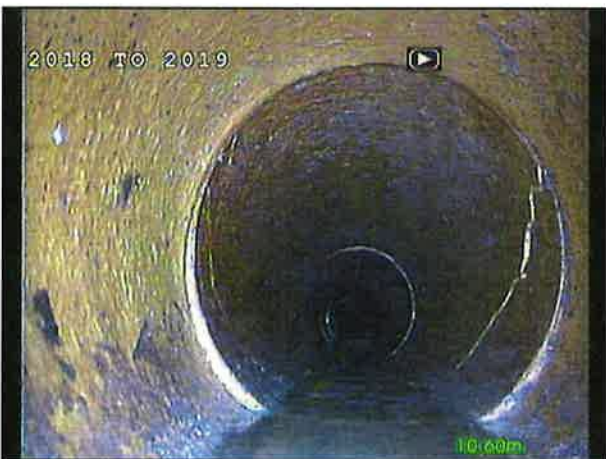
Photo: 19_8a, 00:00:00
 10.6m, Crack Circumferential from 02 to 04 o'clock
