**Our Ref:** DR17/418A-1

**Site:** Proposed Development Site  
47 Holt Road  
Fakenham  
Norfolk  
NR21 8BW

## SUMMARY

## CCTV SURVEY REPORT

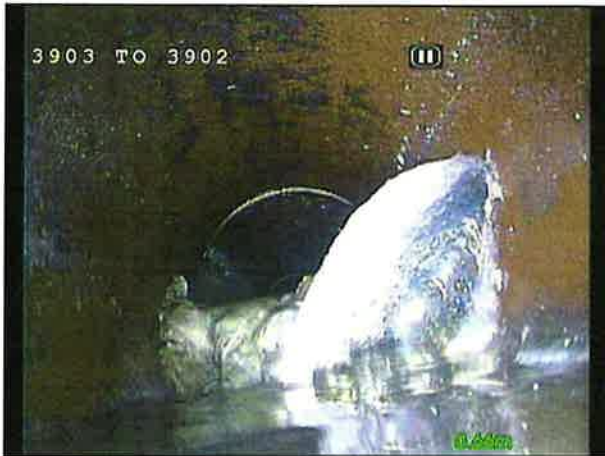
Photo: 2\_2a, 00:00:00  
0.66m, Other settled deposits 40 % cross-sectional area loss

The pipework is serviceable but would benefit from high-pressure cleaning to remove general debris/sewage scale. Minor defects were noted. This cleaning/remedial work would fall under the responsibility of Anglian Water.

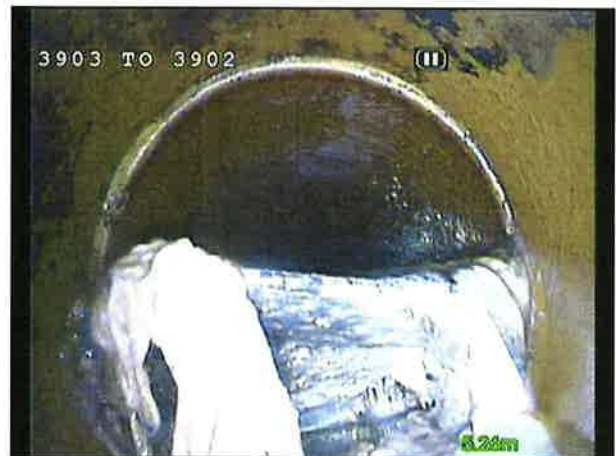
Photo: 3\_3a, 00:00:00  
5.26m, Other settled deposits 50 % cross-sectional area loss

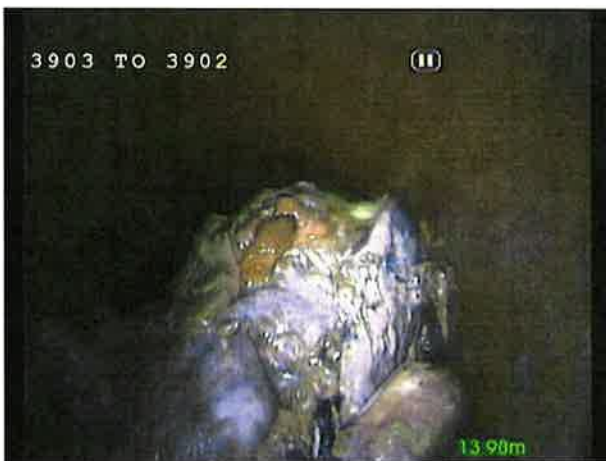
Photo: 4\_4a, 00:00:00  
13.9m, Other settled deposits 80 % cross-sectional area loss

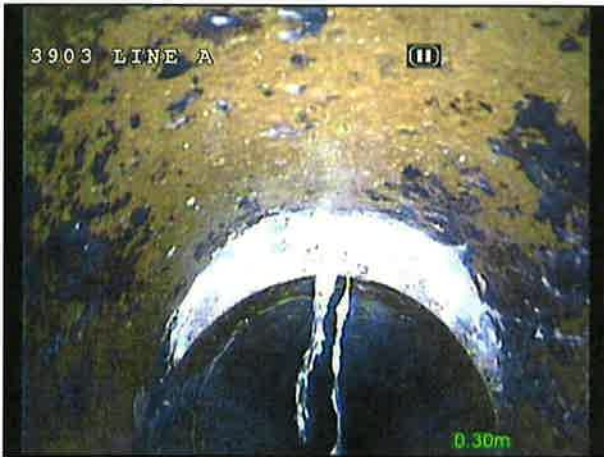
1:200	position	code	observation	counter	photo	grade
<b>Depth: 2.1</b>						
	0.20	MH	Start node type, manhole, reference number: 3903	00:00:00		(Misc) 0
	0.30	JDL	Joint displaced large, from 09 to 03 o'clock	00:00:00	7_2a	(Struct) 2

Photo: 7\_2a, 00:00:00  
0.3m, Joint displaced large, from 09 to 03 o'clock

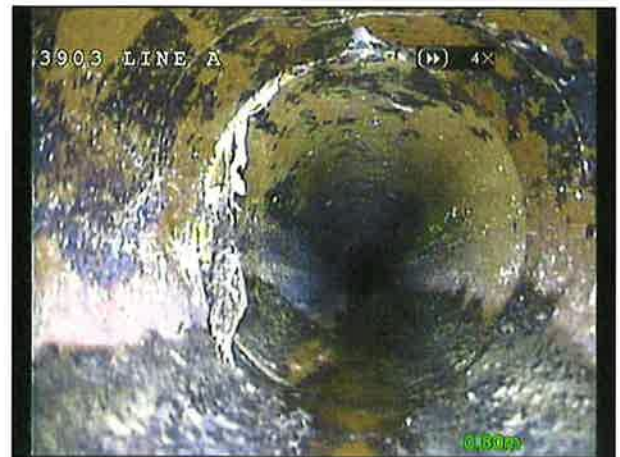
0.79	RF	Roots fine	00:00:00		(Serv) 1
	0.79	CC	Crack Circumferential from 09 to 03 o'clock	00:00:00	9_4a	(Struct) 2
	2.05	CC	Crack Circumferential from 09 to 03 o'clock	00:00:00	10_5a	(Struct) 2

Photo: 9\_4a, 00:00:00  
0.79m, Crack Circumferential from 09 to 03 o'clock

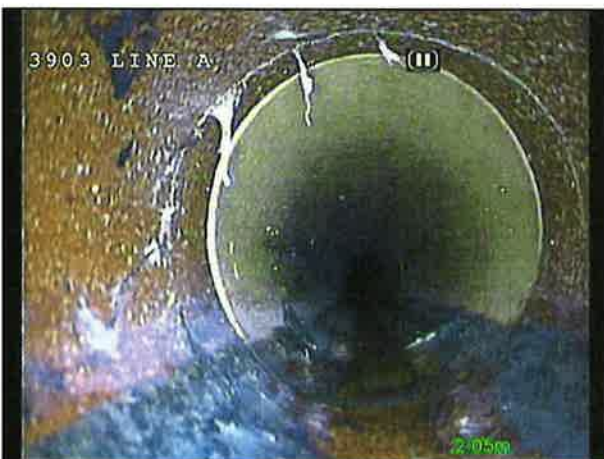
Photo: 10\_5a, 00:00:00  
2.05m, Crack Circumferential from 09 to 03 o'clock

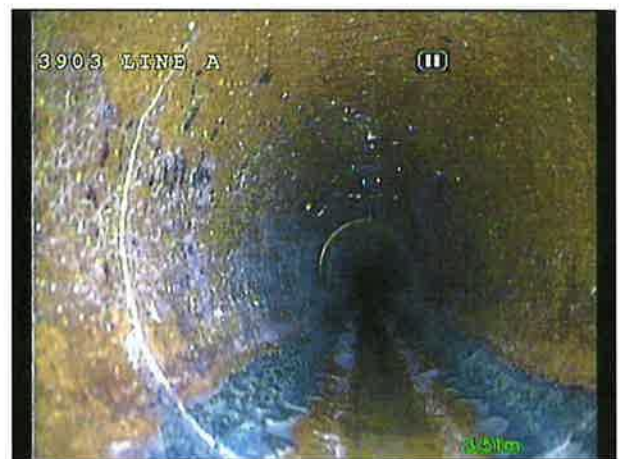
3.51	CC	Crack Circumferential from 06 to 12 o'clock	00:00:00	11_6a	(Struct) 2
	7.13	CC	Crack Circumferential from 07 to 12 o'clock	00:00:00	12_7a	(Struct) 2

Photo: 11\_6a, 00:00:00  
3.51m, Crack Circumferential from 06 to 12 o'clock

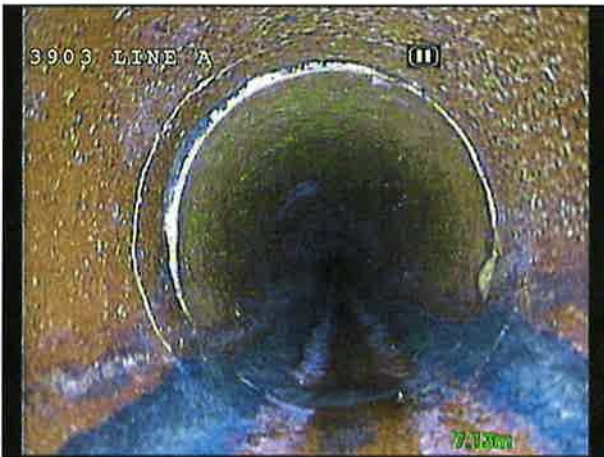
Photo: 12\_7a, 00:00:00  
7.13m, Crack Circumferential from 07 to 12 o'clock

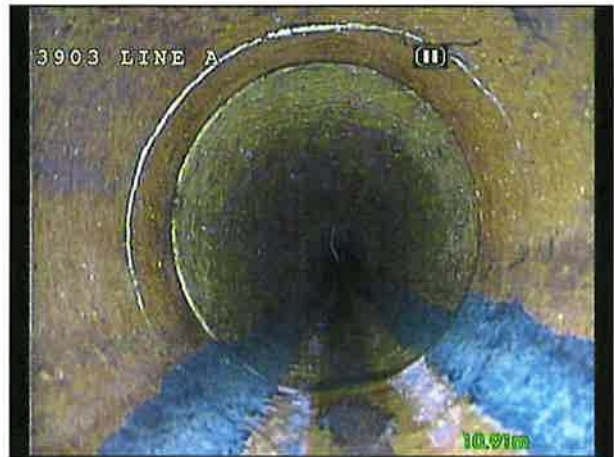
10.91	CC	Crack Circumferential from 07 to 02 o'clock	00:00:00	13_8a	(Struct) 2
	11.56	RF	Roots fine	00:00:00		(Serv) 1
	21.23	REM	General remark - HIDDEN MANHOLE (UNDER FLOORING OF No.47)	00:00:00

Photo: 13\_8a, 00:00:00  
10.91m, Crack Circumferential from 07 to 02 o'clock
