Our Ref: DR17/418A-2

Site: Proposed Development Site
1 Jubilee Avenue
Fakenham
Norfolk
NR21 8DG

CCTV SURVEY REPORT

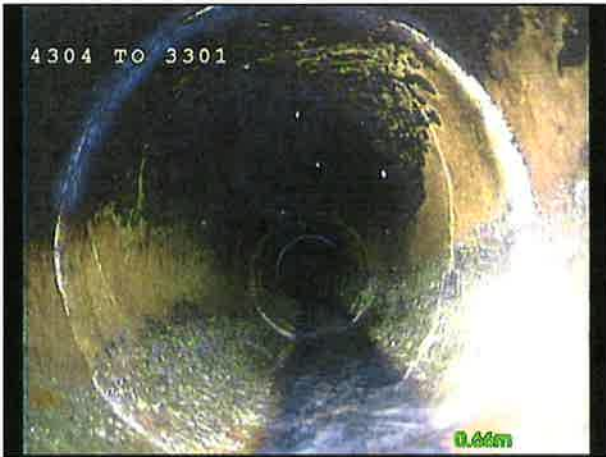
Photo: 2_2a, 00:00:00
0.7m, Crack Circumferential from 01 to 06 o'clock

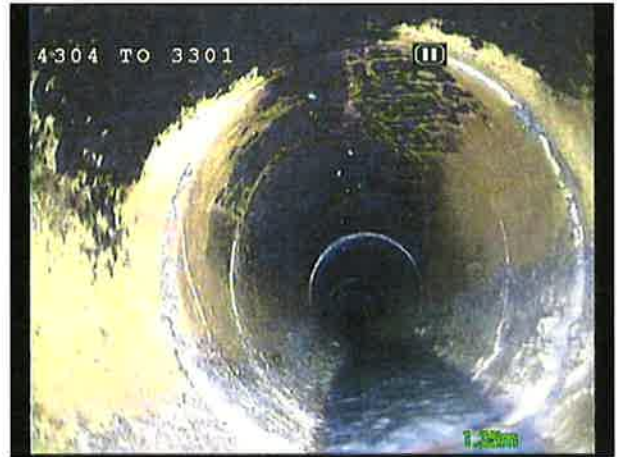
Photo: 3_3a, 00:00:00
1.35m, Crack Circumferential from 02 to 10 o'clock

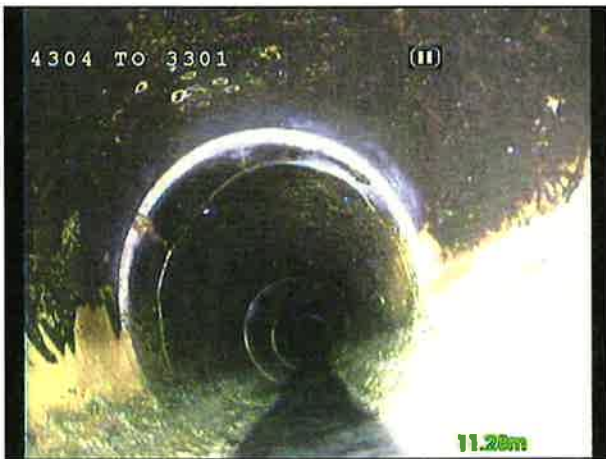
Photo: 4_4a, 00:00:00
11.28m, Crack Circumferential from 07 to 03 o'clock

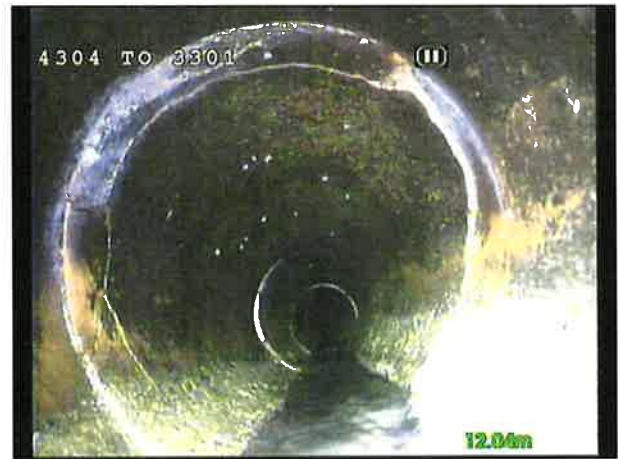
Photo: 5_5a, 00:00:00
12.04m, Crack Circumferential from 07 to 04 o'clock
