11th May 2017

Our Ref: DR17/418A-3

Site: Proposed Development Site
Lancaster Close
Fakenham
Norfolk
NR21 8DJ

CCTV SURVEY REPORT

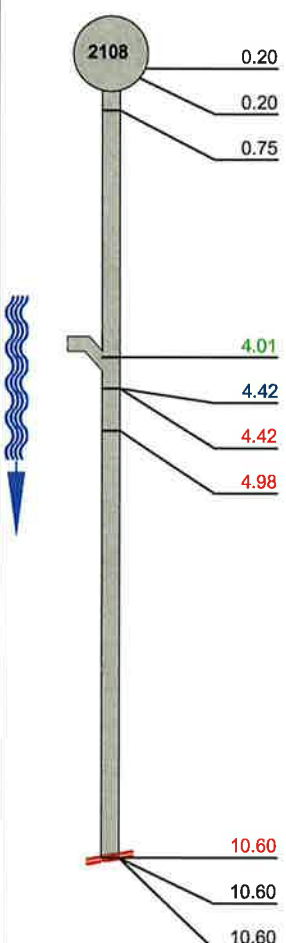
0.20	MH	Start node type, manhole, reference number: 2108	00:00:00		(Misc) 0
	0.20	LD	Line of drain/sewer deviates down	00:00:00		
	0.75	REM	General remark - LINE LEVELS OUT	00:00:00		
	4.01	JN	Junction at 03 o'clock dia 100 mm	00:00:00		(Constr) 0
	4.42	RF	Roots fine	00:00:00		(Serv) 1
	4.42	CC	Crack Circumferential from 08 to 04 o'clock	00:00:00	17_6a	(Struct) 2
	4.98	CC	Crack Circumferential from 12 to 12 o'clock	00:00:00	18_7a	(Struct) 2
	10.60	CC	Crack Circumferential from 02 to 04 o'clock	00:00:00	19_8a	(Struct) 2
	10.60	SA	Survey abandoned, BEYOND SURVEY REQUIREMENTS	00:00:00		(Misc) 0
	10.60	REM	FINAL TOTAL METERAGE UNKNOWN	00:00:00
